Report No. FHWA-RD-75-62

DESIGN AND CONSTRUCTION OF COMPACTED SHALE EMBANKMENTS

Vol. 2. Evaluation and Remedial Treatment of
Shale Embankments

G. H. Bragg, Jr. and T. W. Zeigler

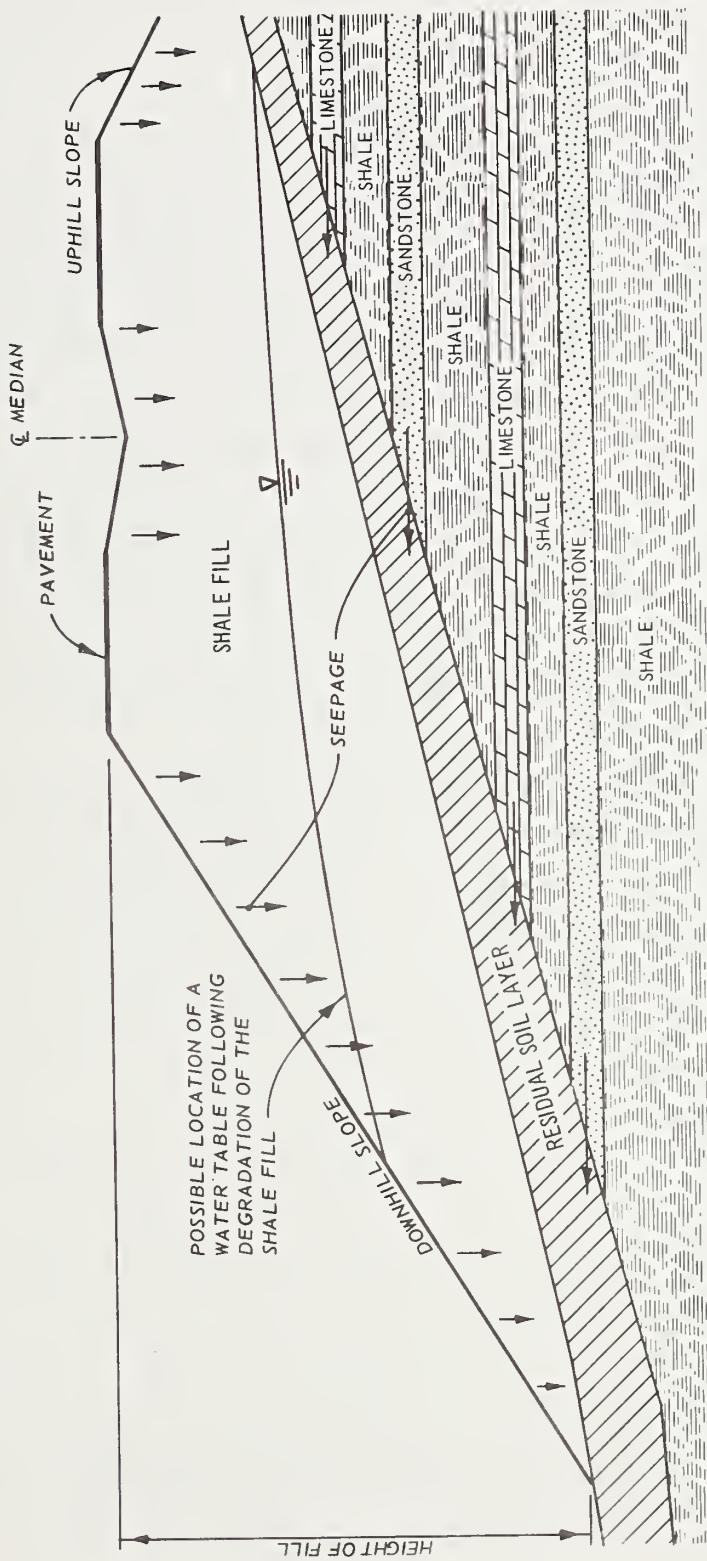
Many sidehill fills are underlain by a layer of residual soils (commonly 5 to 20 ft thick) overlying the parent shale formations (see Figure 1). These soils are commonly involved in the sidehill fill failures, although the degradation of the embankment shale may be largely responsible for failure. For example, during rainy periods the residual soils (like the embankment) may be subjected to saturation and increased pore water pressures due to the constriction of drainage through the deteriorated embankment. The reduction in shear strength of the residual soils may be significant and lead to their involvement in failure of the sidehill fill. These failures are considered within the scope of this report since the embankment characteristics and behavior were likely major contributors to failure. The possible involvement of

Figure 1. Movement of water through a sidehill embankment.

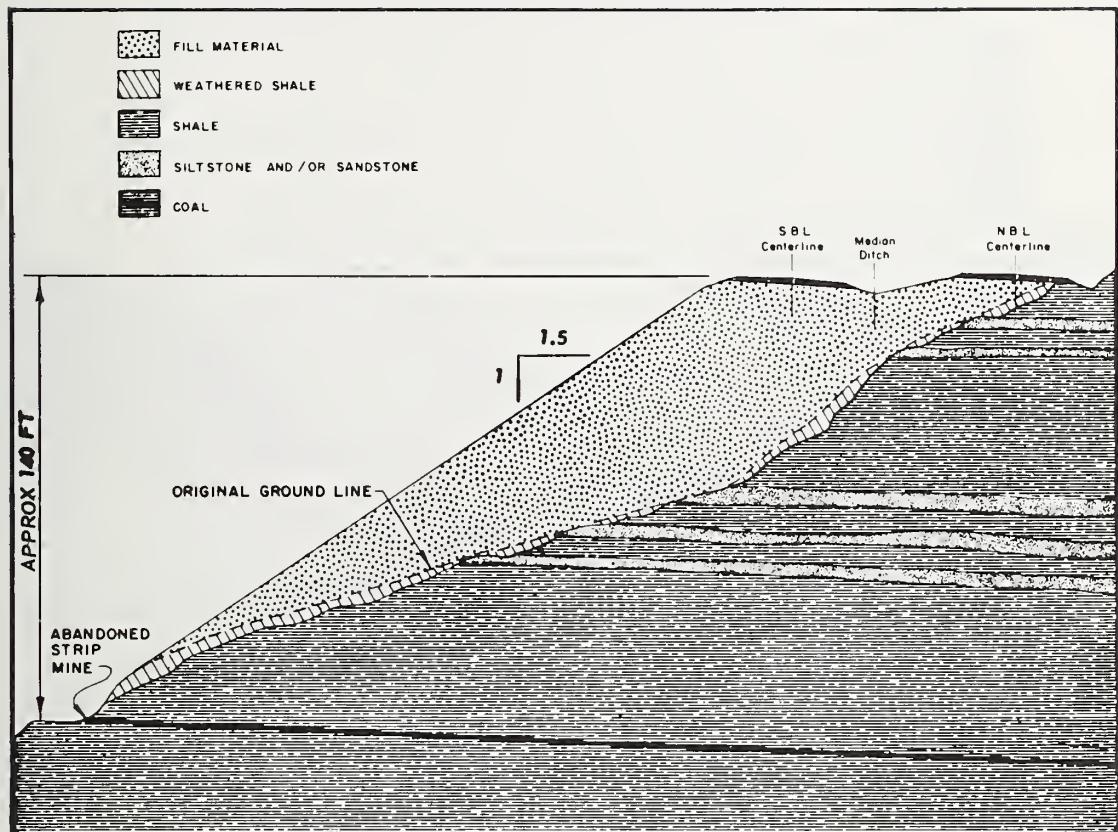
subsidence required periodic pavement overlays. This failure and other embankment failures along I-75 were investigated and results reported by Law Engineering Testing Company (1972).* The slide and subsequent investigations at sta 840+00 are also discussed by Tice and Sams (1974). The embankment was a sidehill fill approximately 140 ft in height** and included zones of rapidly deteriorating siltstone and shale. Water entering the fill from surface runoff and subsurface seepage apparently caused deterioration of the shale. Slope inclinometer data and boring explorations indicated that the shear surface was contained largely within zones of shale-siltstone fragments surrounded by a silty clay matrix. Water level data indicated the existence of a water table high within the fill, and numerous areas of seepage were observed on the failed slope. According to Royster (1973), the failure was initiated in the toe area and progressed upslope. The original embankment, failure stages, and corrected slope are depicted in Figures 3-6.

Figure 3. Sta 840+00, I-75, embankment as constructed (Royster, 1973).

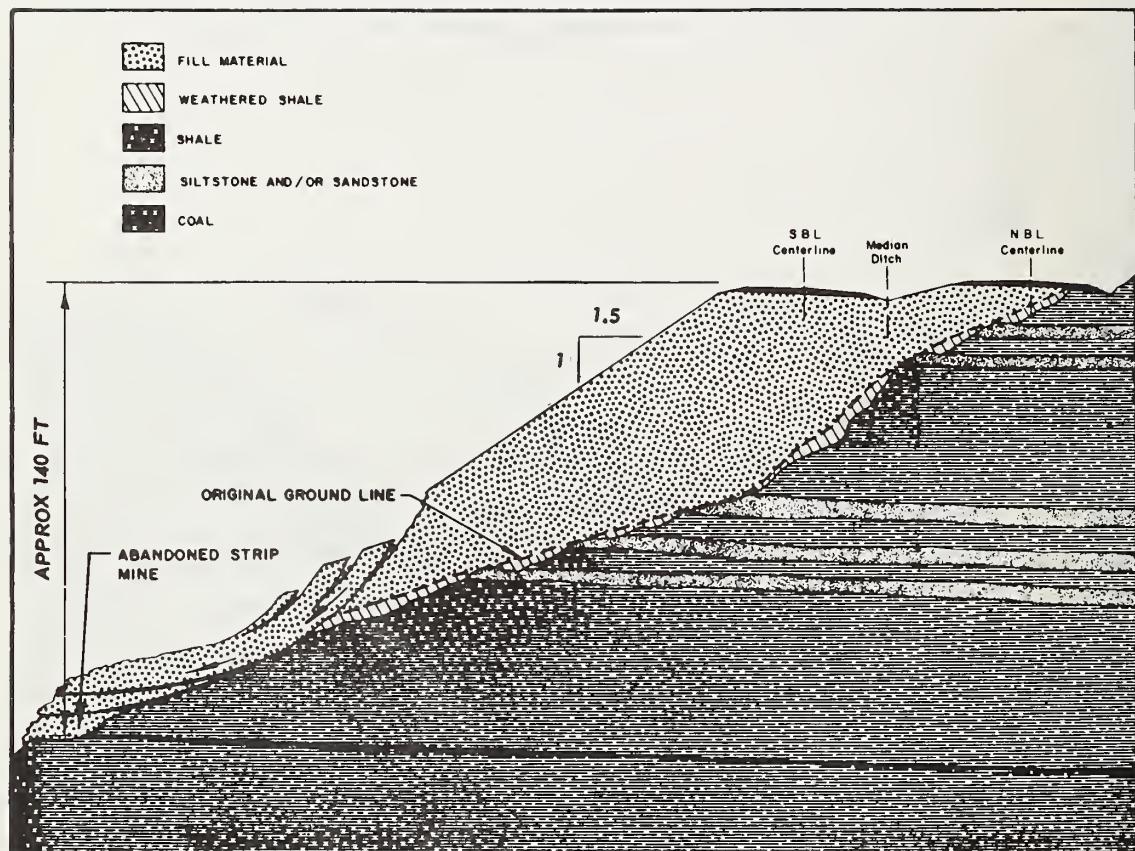
Figure 4. Sta 840+00, I-75, embankment in first stage of failure (Royster, 1973).

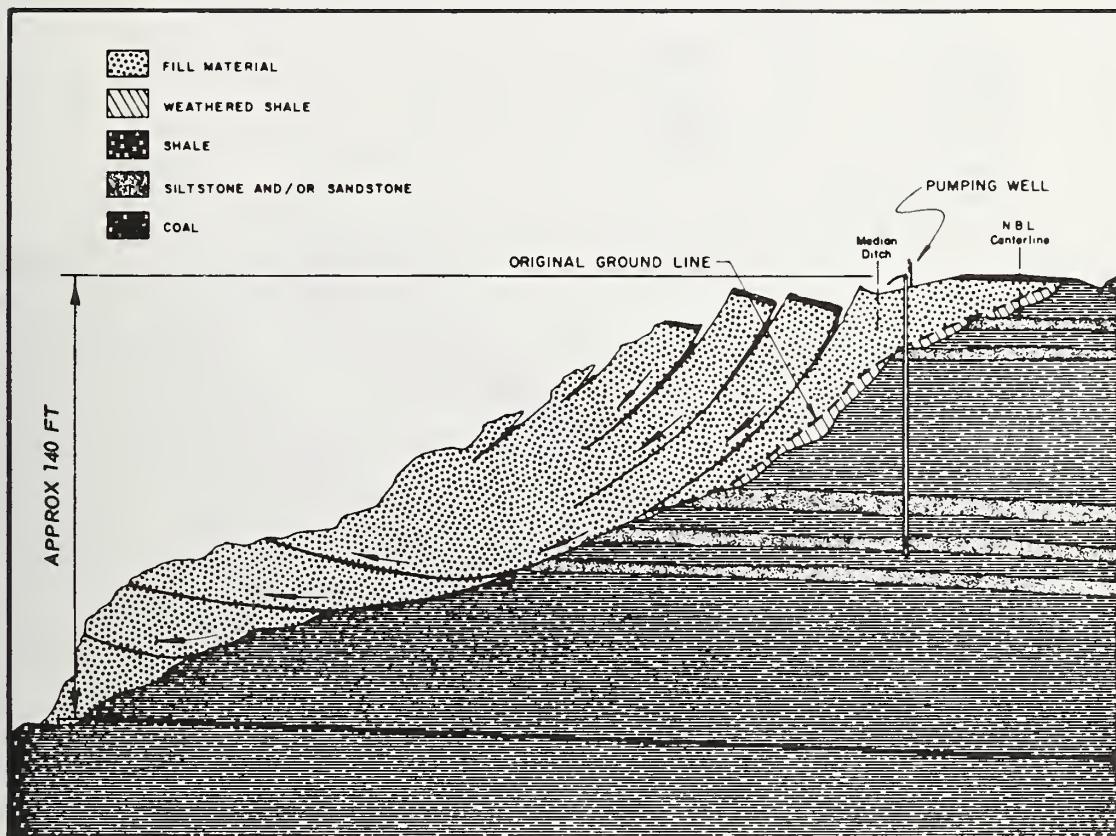
Figure 5. Sta 840+00, I-75, embankment in last stage of failure (Royster, 1973).

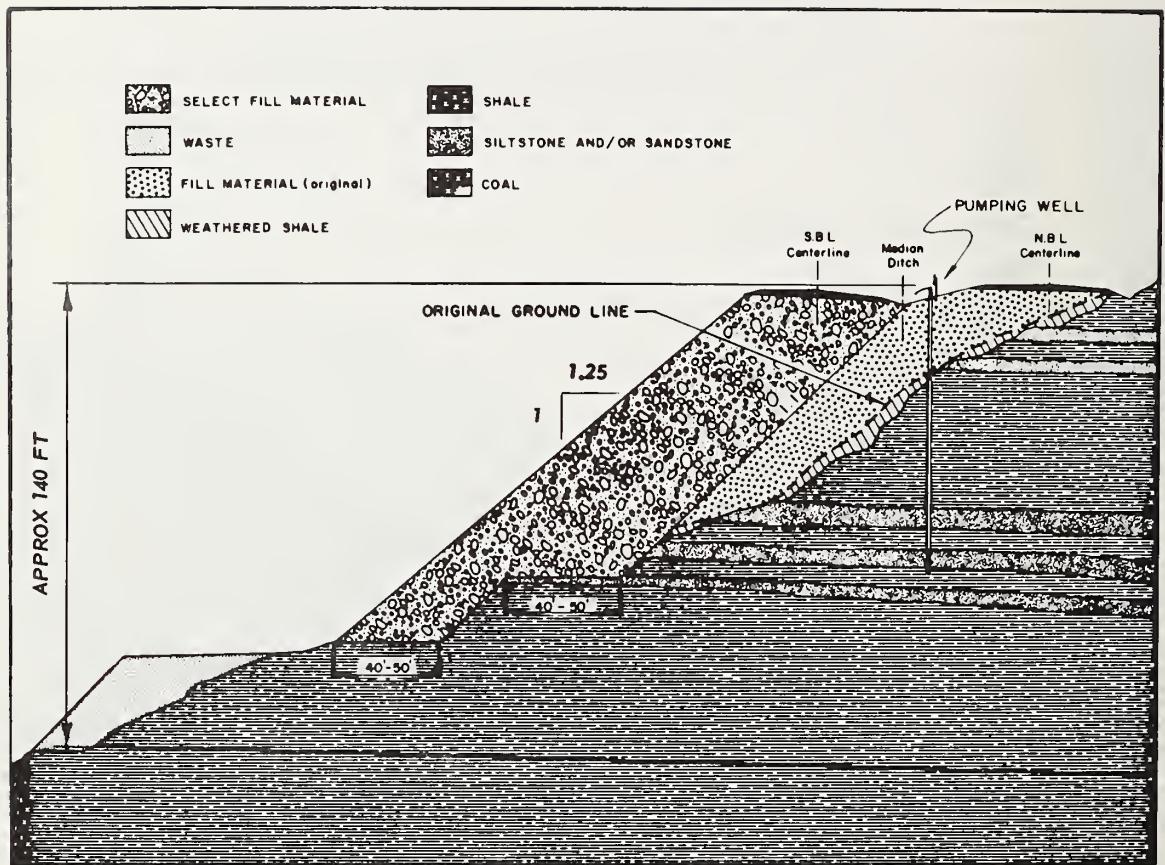
Figure 6. Sta 840+00, I-75, embankment after repair (Royster, 1973).

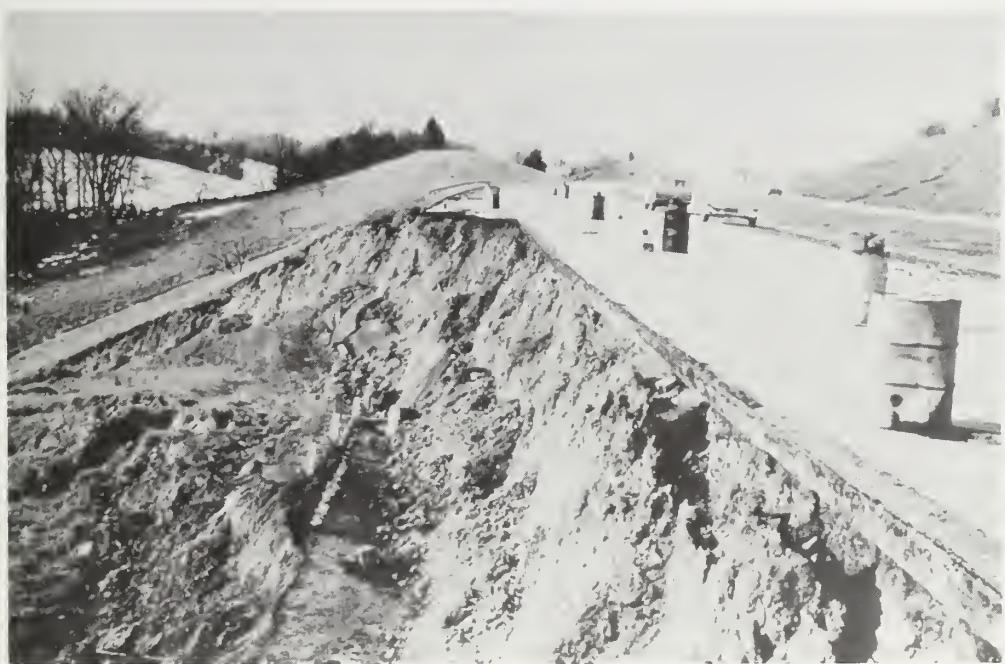
Figure 9. Western portion of failure scarp, SLIDE-1 on I-74, Indiana (courtesy of the Indiana State Highway Commission).

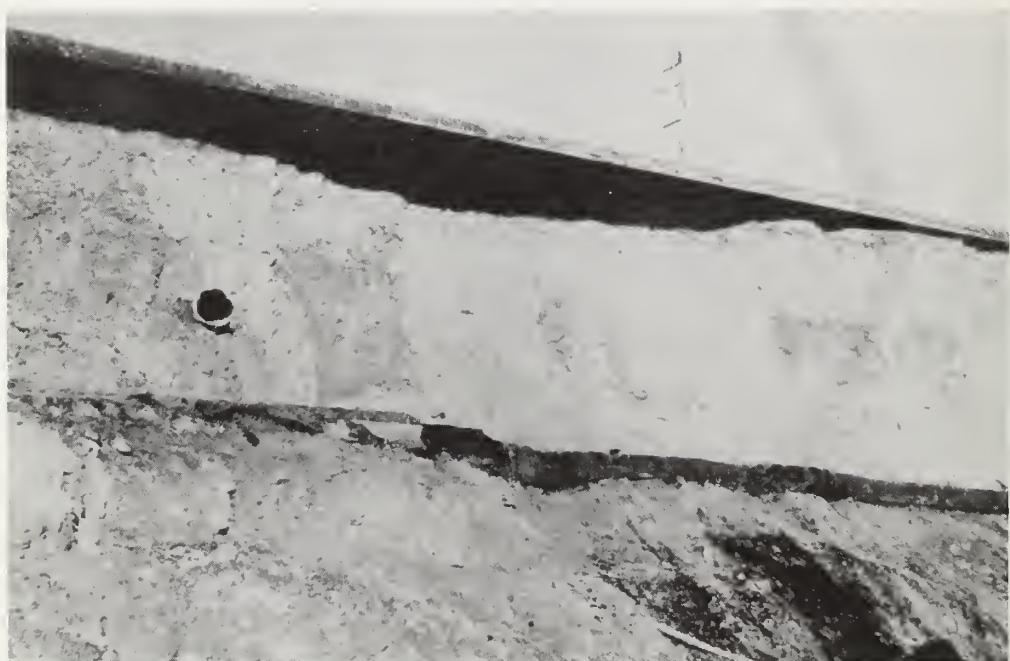
Figure 10. Central portion of failure scarp, SLIDE-1 on I-7⁴, Indiana (courtesy of the Indiana State Highway Commission).

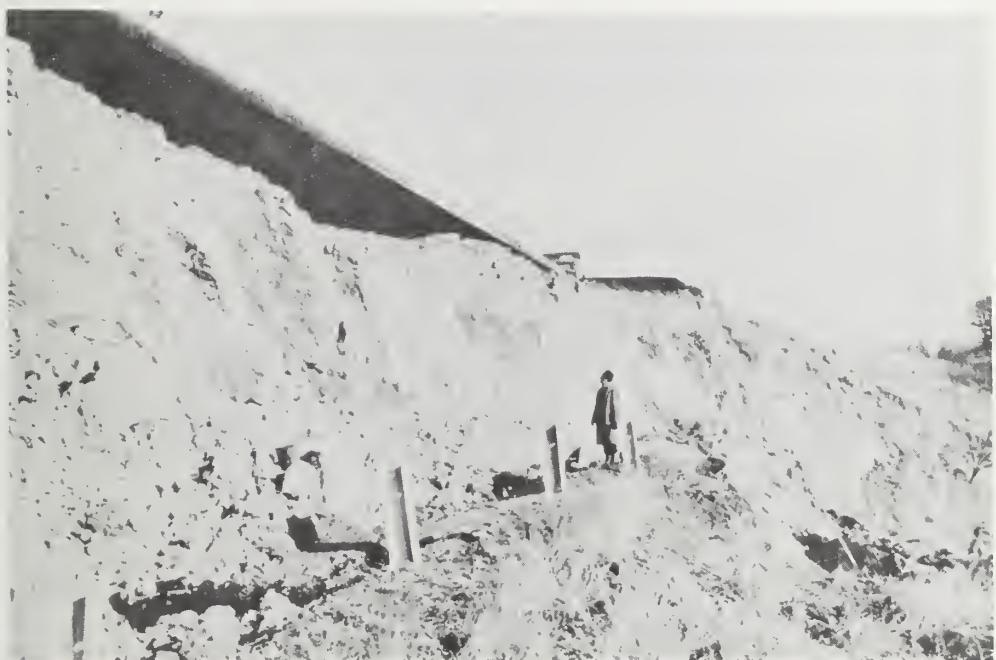
Figure 11. Eastern portion of failure scarp, SLIDE-1 on I-74, Indiana (courtesy of the Indiana State Highway Commission).

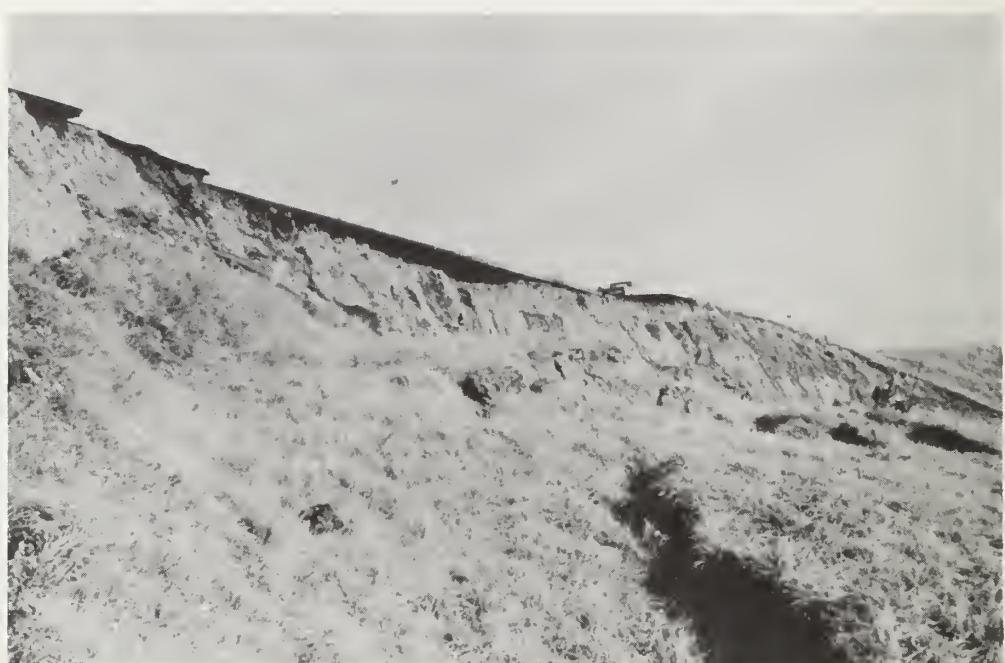
Figure 12. Failed slope, SLIDE-1 on I-74, Indiana
(courtesy of the Indiana State Highway Commission).

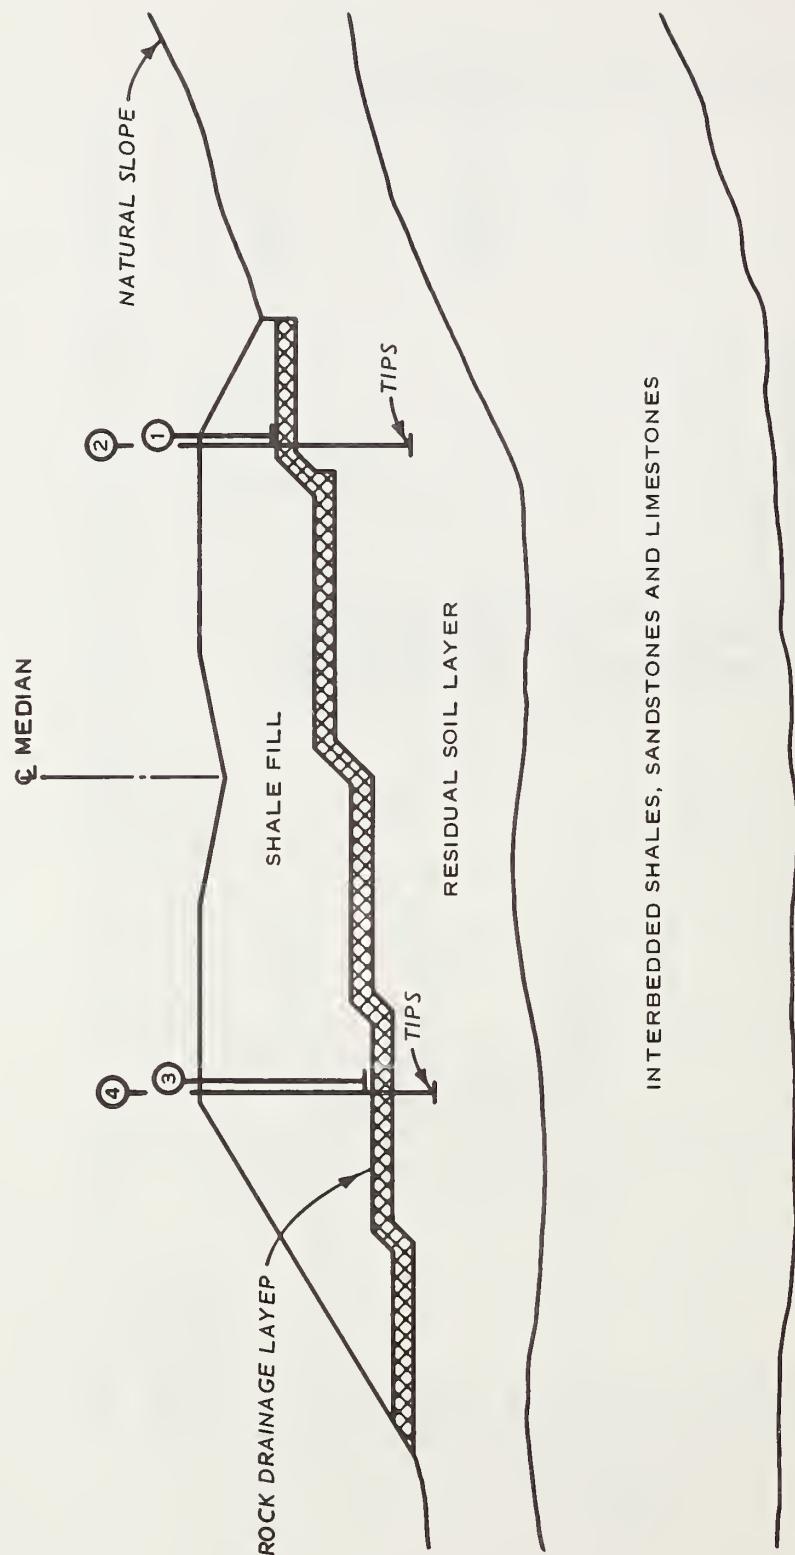
Figure 15. Typical piezometer locations.

rainfall data or local stream flow can pinpoint the source of water within a fill. Examination of the readings will indicate a well drained fill if readings for embankment piezometers 1 and 3 are always near the elevation of the top of the drainage blanket or if they are always dry. Piezometers 2 and 4 will reflect groundwater elevations within the foundation. A fill with poor drainage will conversely be indicated if piezometers 1 and 3 indicated piezometric elevations within the embankment; and foundation piezometers 2 and 4 also indicated elevations within the embankment. In such a case, the embankment will have actually blocked a natural drainage pattern, a condition long recognized as potentially dangerous (Highway Research Board, 1958). Further indications of poor drainage can be seen if the water surface elevations in piezometers 1 and 3 increased within the embankment following periods of heavy rainfall and took an extended time to regain their normal levels after the rainfall had ceased.

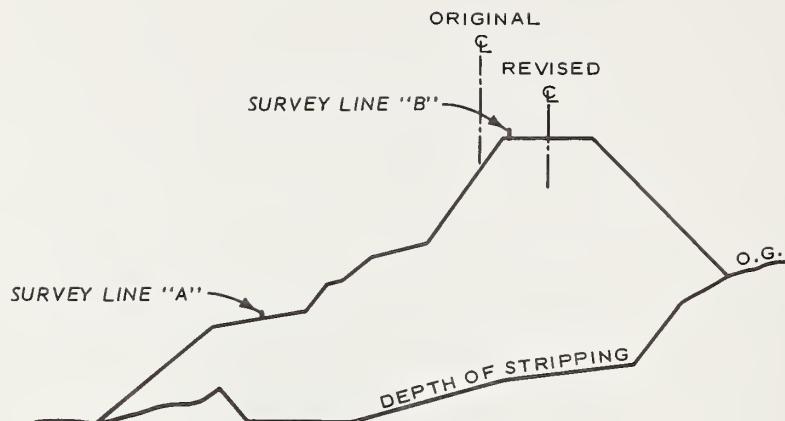
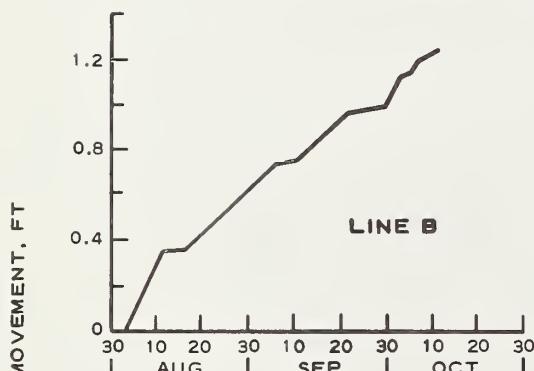
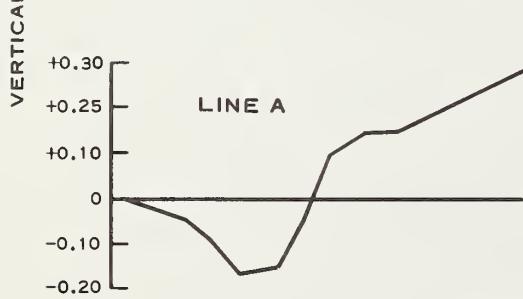
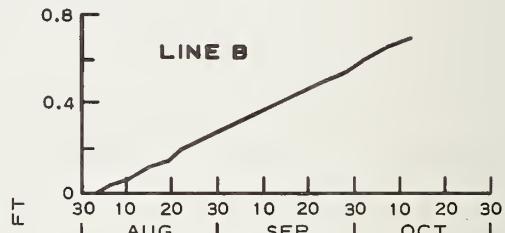
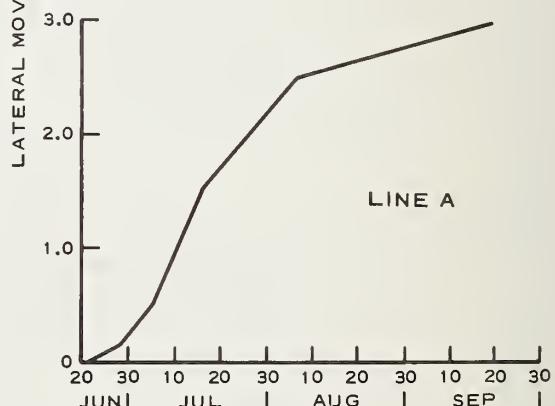
a. EMBANKMENT CROSS SECTION

b. VERTICAL MOVEMENT

c. LATERAL MOVEMENT

Figure 17. Vertical and lateral movement of highway embankment on U. S. 101 in California (after Durr, 1974).

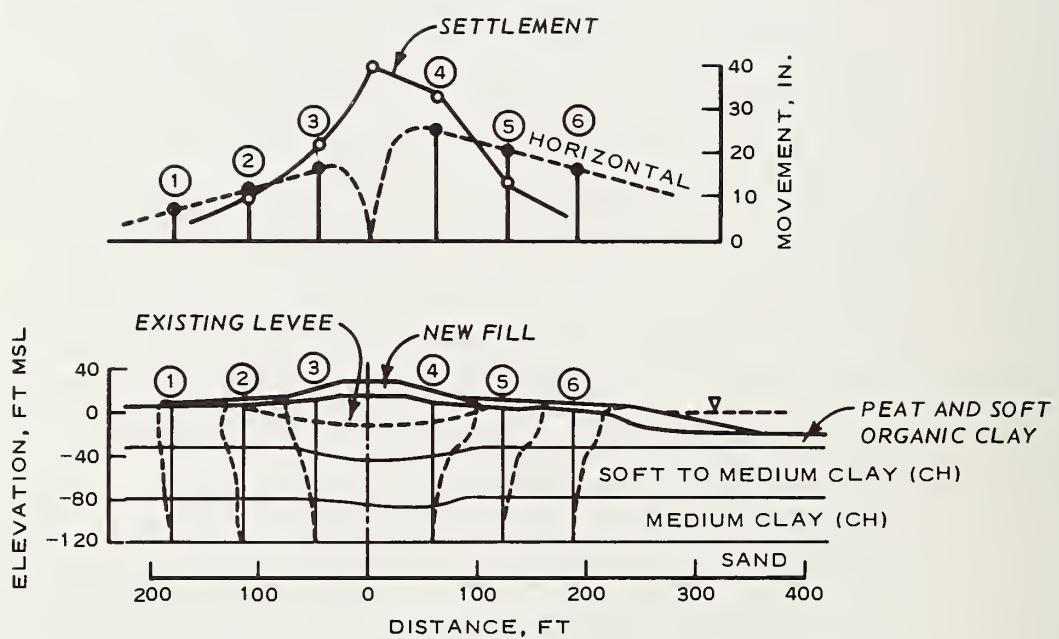
Figure 21. Foundation movement indicated by slope inclinometer data, Atchafalaya Levee, Louisiana (Wilson, 1970).

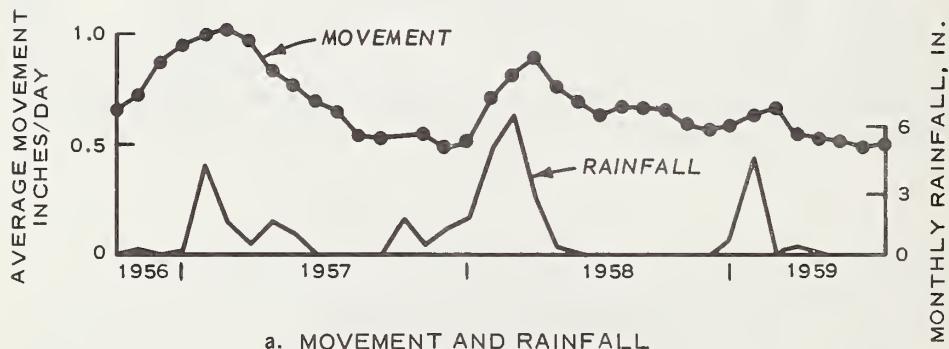
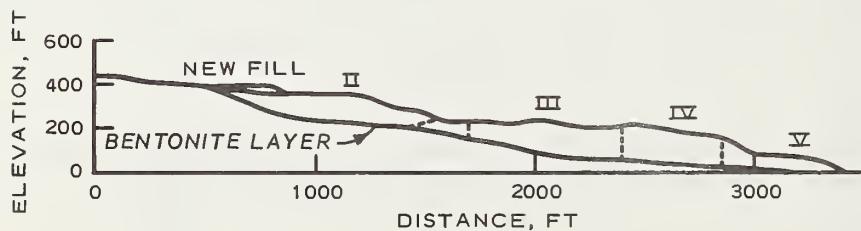
Wilson (1970) reports movements of a natural slope (Portuguese Bend, California) that were initiated by placement of slide debris adjacent to an existing roadway in the spring and summer of 1956. Cracking of a concrete outlet structure beneath the roadway was found which required frequent repair. Inclinometers were installed and movement was still being observed in 1970. In another case illustrated in Figure 17, early detection of horizontal movement and settlement led to the initiation of remedial measures that corrected the problem and made reconstruction unnecessary (Durr, 1974).

a. MOVEMENT AND RAINFALL

b. PROFILE OF LANDSLIDE

Figure 23. Movements at Portuguese Bend Landslide, California (Wilson, 1970).

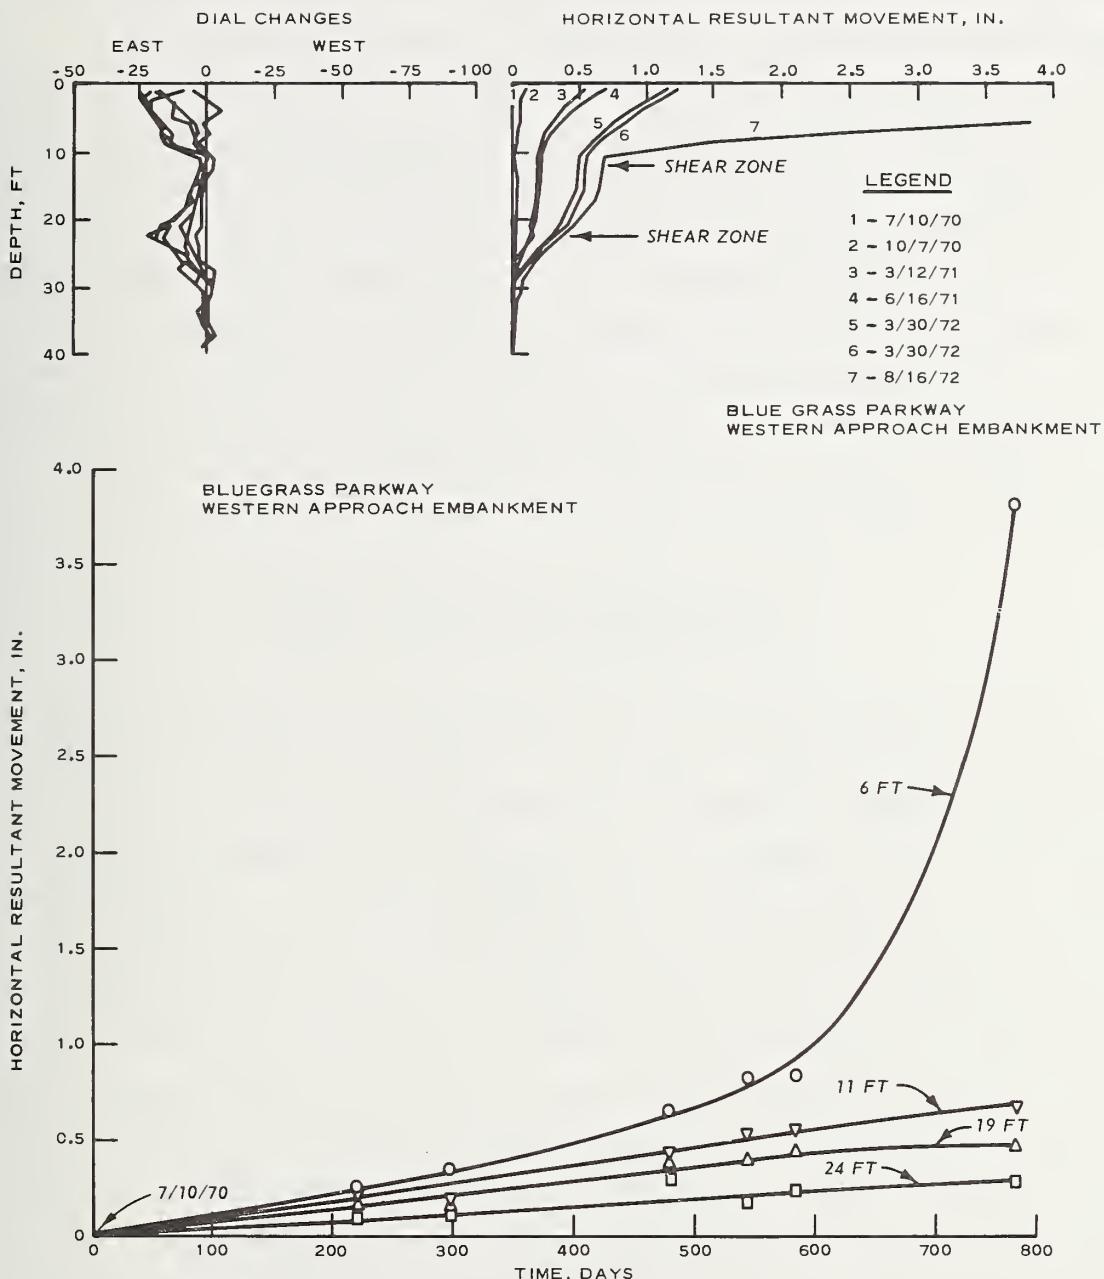
Figure 24. Slope inclinometer results, western approach embankment, Chaplin River Bridges, Bluegrass Parkway, Kentucky (Hopkins, 1973).

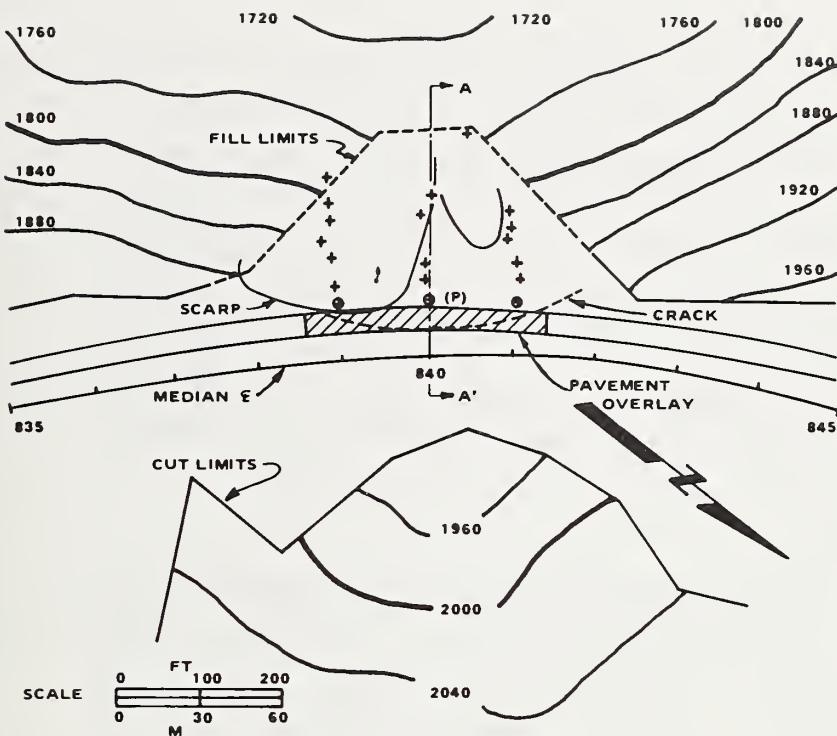
Two of the States contacted in the study had used the Menard pressuremeter for investigations of embankments. Law Engineering Testing Company applied the Menard pressuremeter to in situ testing of three compacted shale embankments on I-75 in Tennessee. Figure 29 shows the plan and section of one of these fills, and Figure 30 shows a comparison of laboratory data, standard penetration resistances, and pressuremeter data. Pressuremeter data were used in combination with laboratory strength data in the evaluation of two of the I-75 fills. The presence of gravels in the third fill precluded extensive use of the pressuremeter and the fill was analyzed using assumed strength values based on experience obtained in testing the other fills.

Figure 29. Plan and section of sidehill fill failure at sta 840+00, I-75, Campbell County, Tennessee (Tice and Sams, 1974).

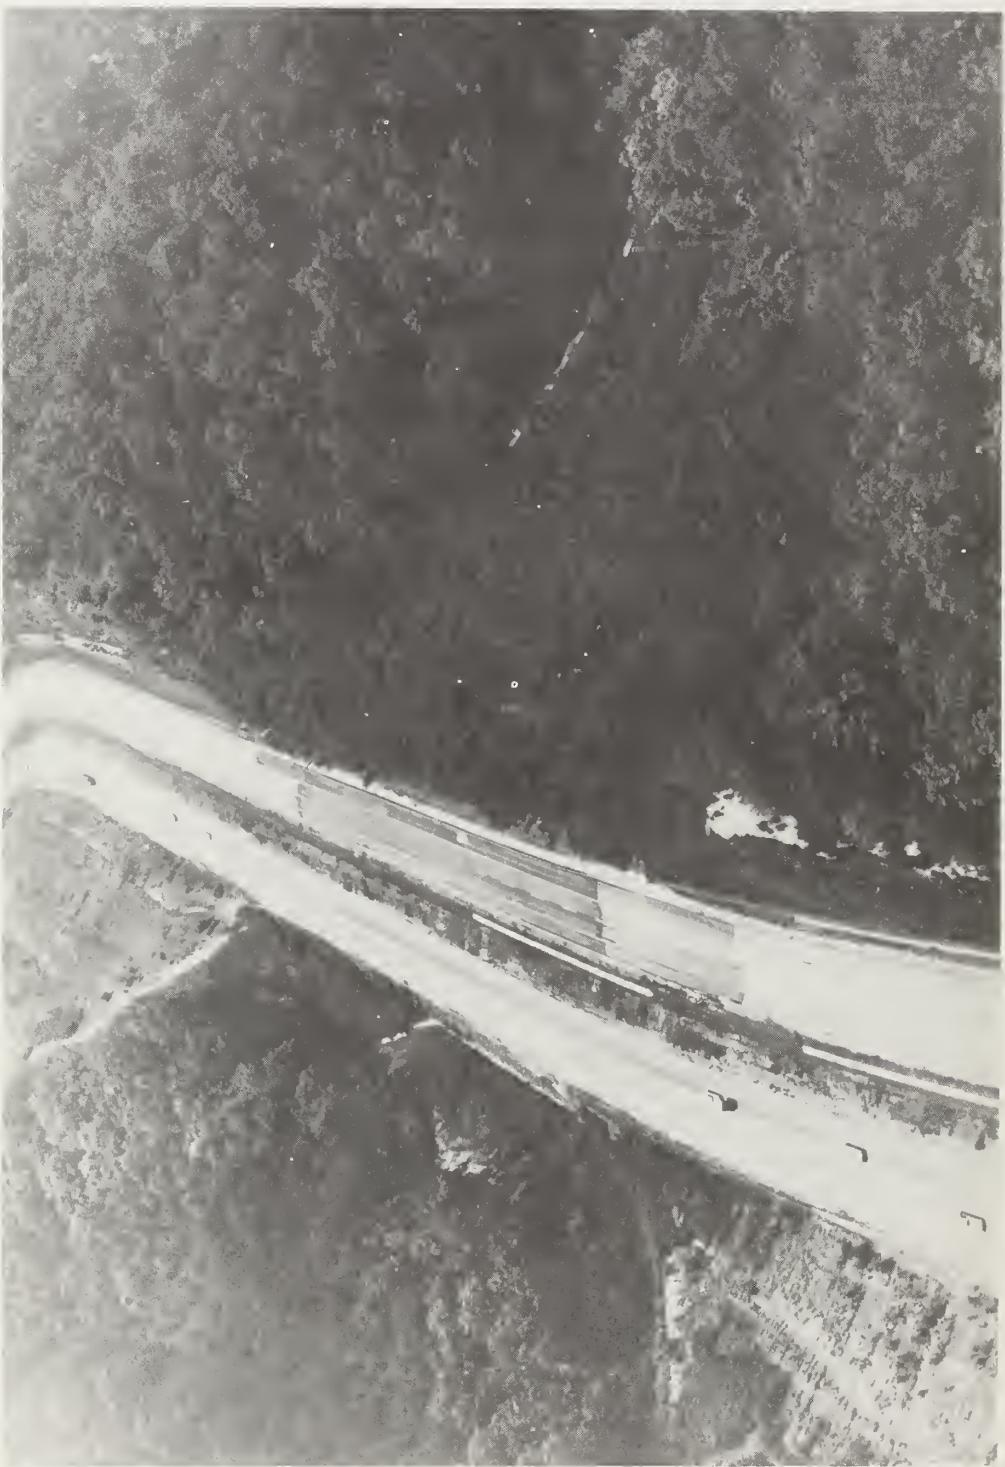
Figure 45. Pavement overlay, sta 950+00, I-75, Tennessee (courtesy of the Tennessee Department of Transportation).

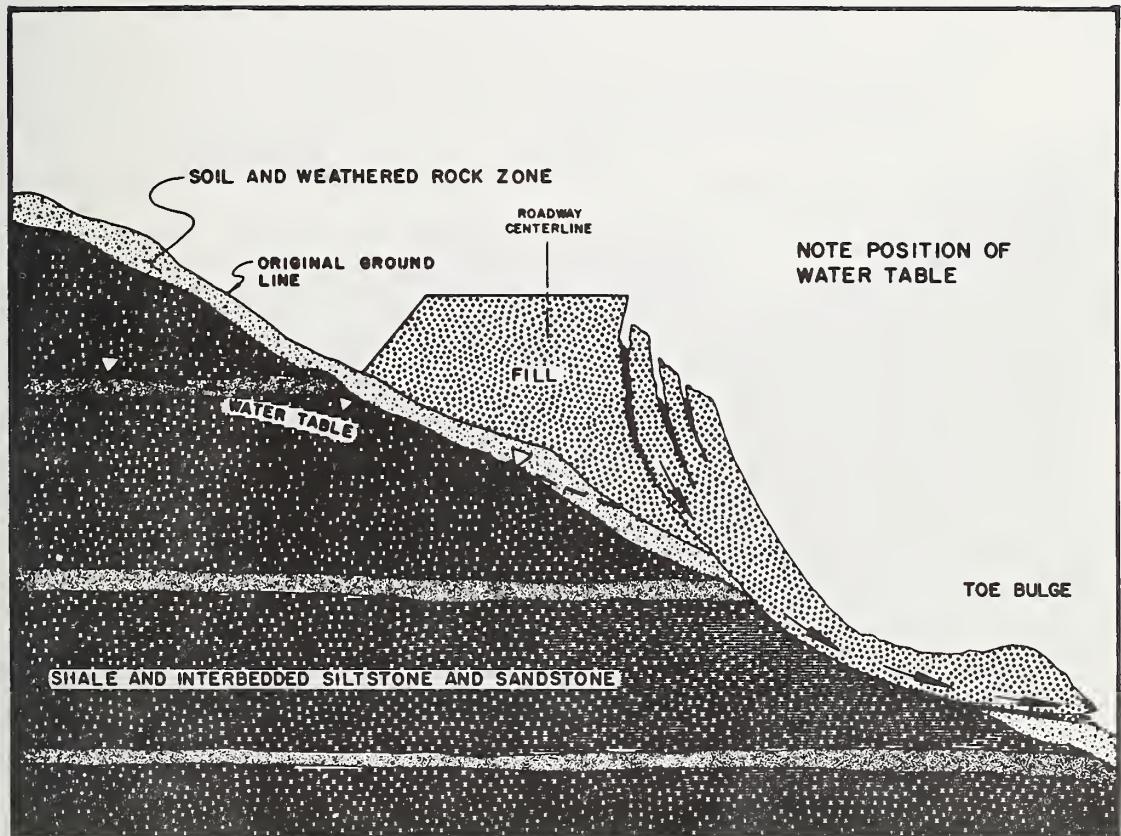
Figure 49. Sta 1464+00, I-75, embankment at failure (Royster, 1973).

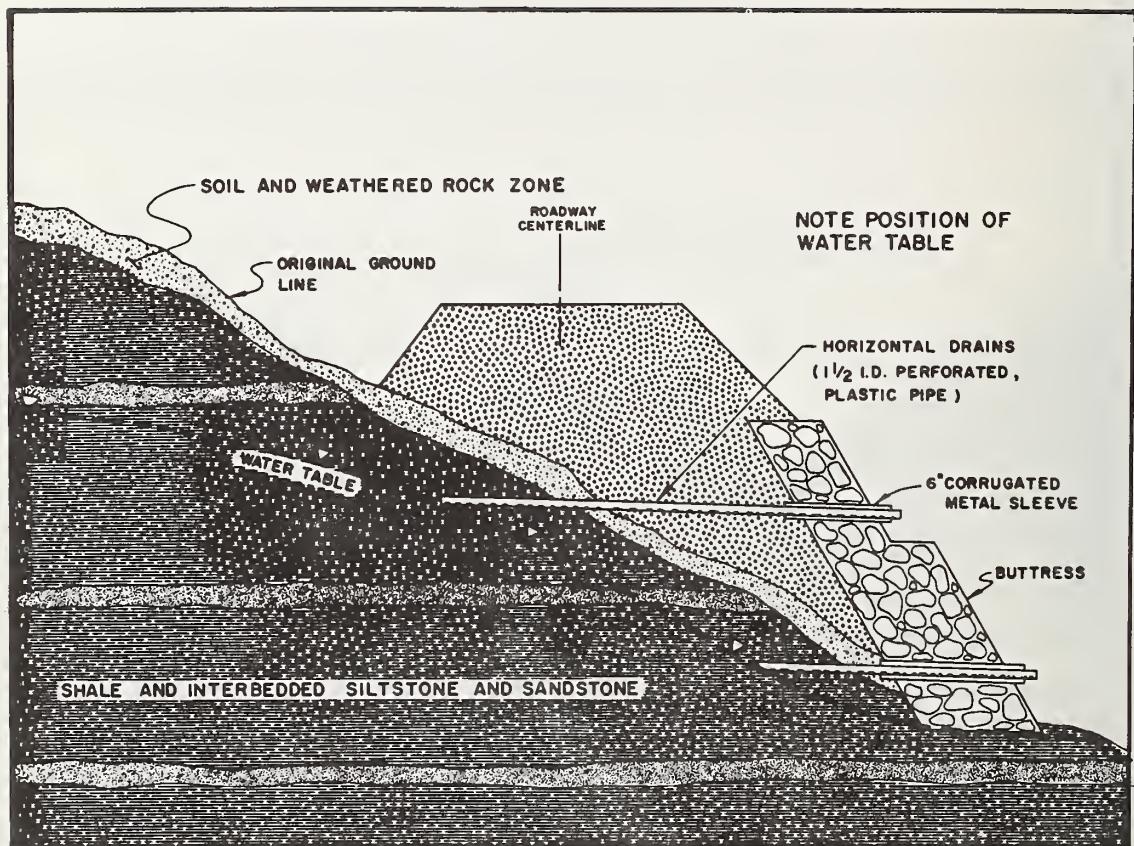
Figure 50. Sta 1464+00, I-75, embankment after repair (Royster, 1973).

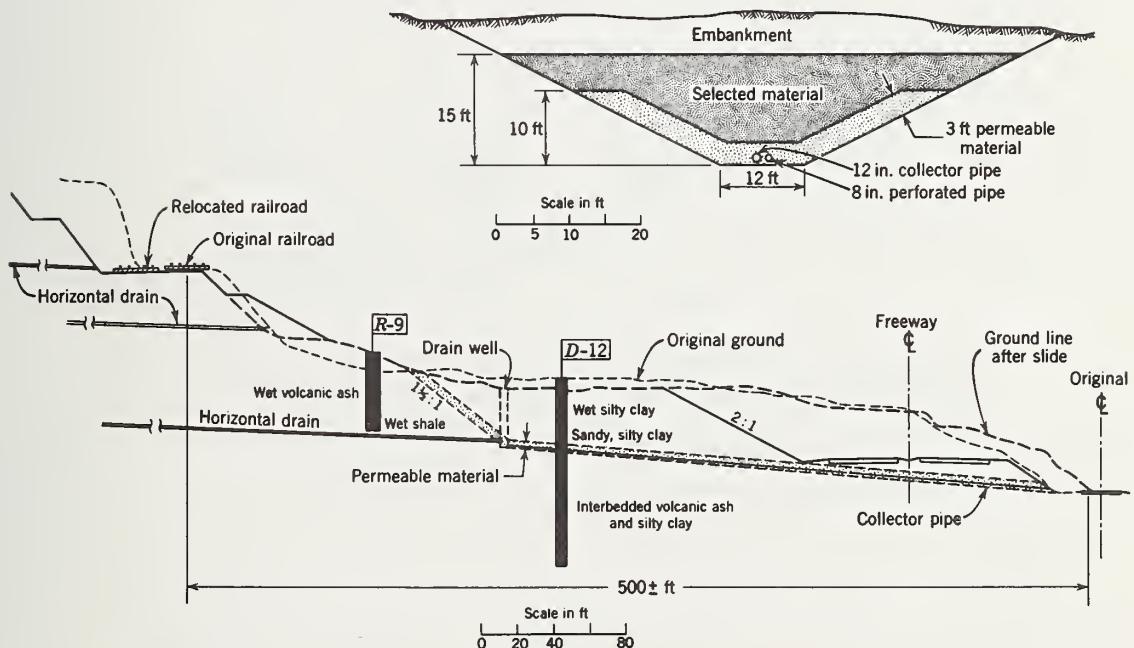
Figure 55. Remedial treatment of a slide near Towle, California (Cedergren, 1967).

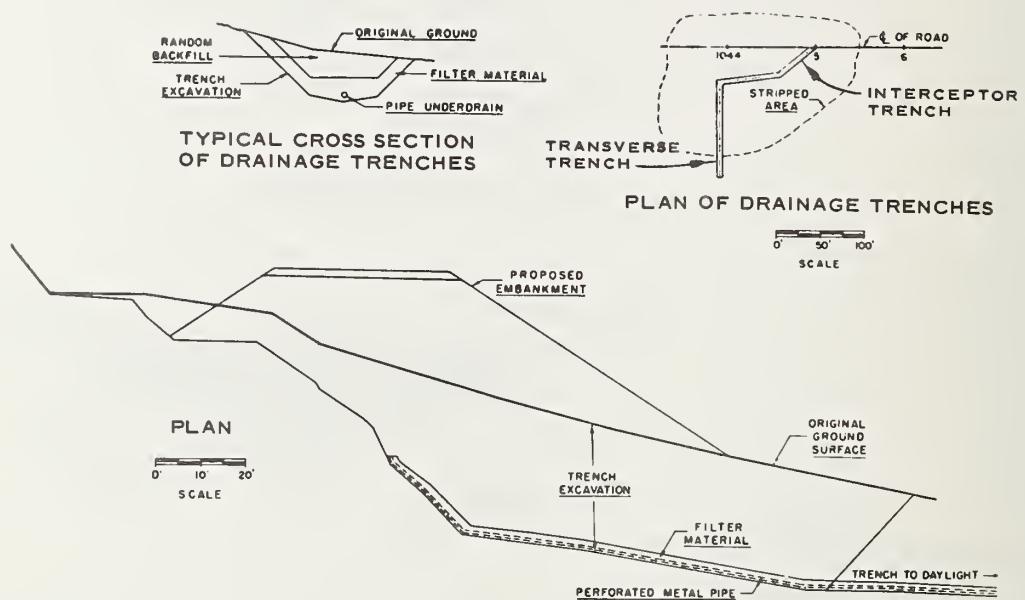
Trench drains are most conveniently installed prior to initial construction of the embankment. The example in Figure 56 shows an interceptor trench and connecting transverse trench to be constructed under a proposed sidehill embankment (Root, 1958). As shown in Figure 56, weak soils should be stripped before construction of the trench drains to provide a firm foundation and direct contact with aquifer layers. To avoid total reconstruction of a lengthy embankment, deep transverse trench drains can be spaced intermittently along the length of the embankment or shear trenches can be used. Shear trenches oriented parallel to the slope crest and commonly used beneath berms (Figure 64, page 140) or incorporated into embankment slopes (Figure 84, page 189) serve as interceptor trench drains to facilitate drainage of sidehill fills and foundations. As shown in Figures 64 and 84, a perforated pipe should be placed at the inside toe of the trench to collect water and carry it to the trench outlets. Although the trench backfill normally consists of coarse, nondegradable rock fill, a drainage blanket

Figure 56. Plan and cross section of preventive treatment consisting of stripping unsuitable soil and constructing drainage trenches (Root, 1958).

(minimum thickness of 3 ft) should be placed along the trench bottom and backslope to prevent future clogging of the backfill and/or collector pipe. Shear trenches are normally cut into firm foundation materials. This is particularly important in preventing differential settlements which may damage collector pipes.

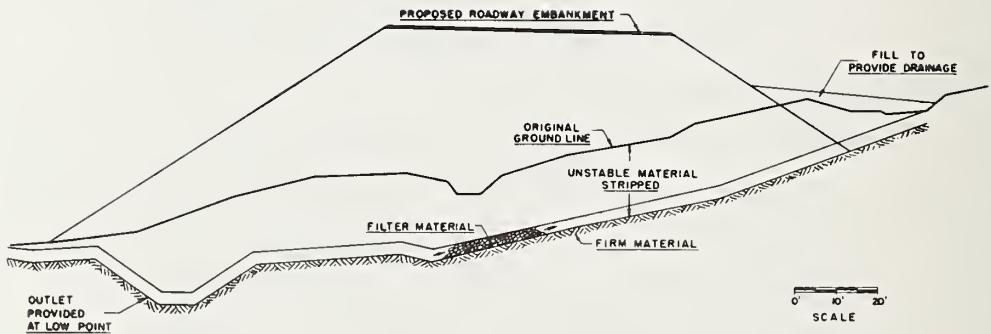
Drainage blankets. A drainage blanket is commonly used to collect subsurface seepage beneath a sidehill fill. The drainage blanket usually consists of a layer of coarse, free-draining material placed along the embankment foundation contact. If large flows are expected (e.g. from natural springs), a drainpipe may be included within the blanket. Root (1958) recommends that weak foundation soils be removed and the blanket be placed on a firm foundation as shown in Figure 57.

Figure 57. Typical cross section of Redwood Highway in Humboldt County, California, showing stripping of unstable material and placement of drainage blanket before constructing embankment (Root, 1958).

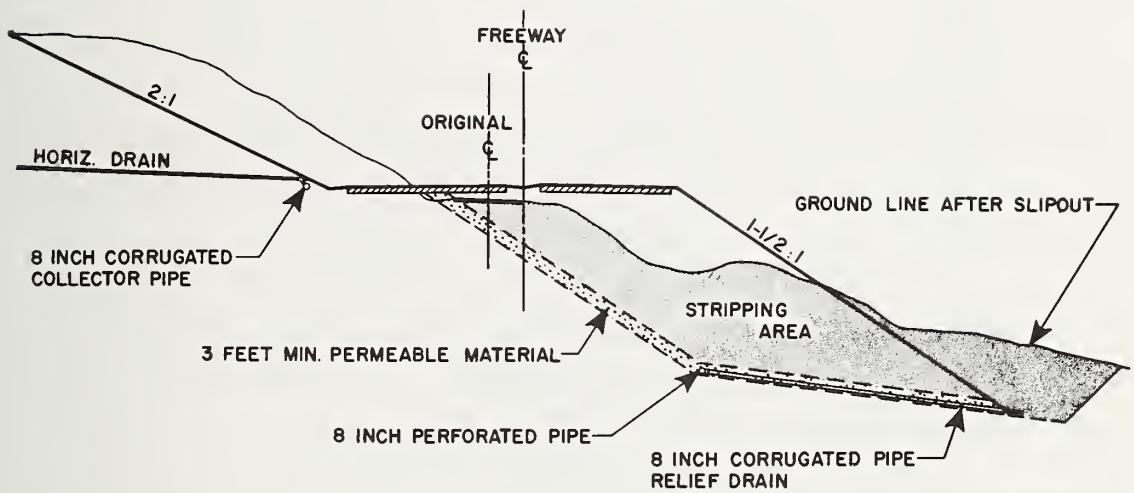
The use of a drainage blanket in remedial treatment generally requires that a portion of the unstable slope material be removed. A 3-ft-thick drainage blanket was placed beneath a sidehill fill constructed in repair of a landslide which occurred in 1955 near Baxter, California (Smith, 1962). In this case, the slide material consisted of a saturated mass of tuffaceous silty clay overlying serpentine. Horizontal drains were installed above and below the failed slope to provide temporary stability during reconstruction. Horizontal drains at road level remained as part of the final correction scheme. Weak surface material was stripped to depths of 30 ft prior to placement of the drainage blanket and collector pipe shown in Figure 58.

Figure 58. Drainage blanket used beneath a sidehill fill constructed as part of a remedial treatment of a landslide near Baxter, California (Smith, 1962).

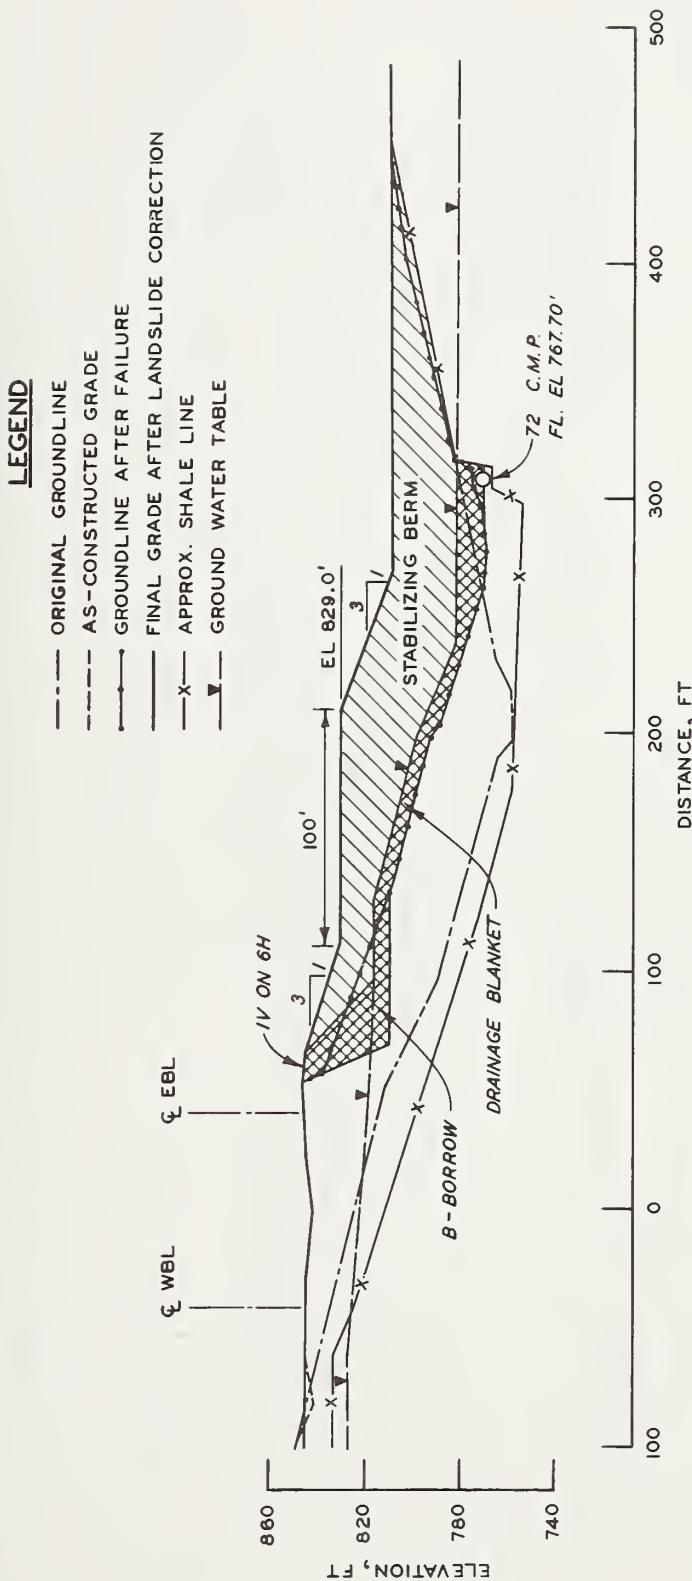
Drainage blankets have been used successfully when placed directly on the failed slope and overlain by a berm. Stabilizing berms and drainage blankets used in repair of SLIDES-1 and -2 on I-74, Indiana, are shown in Figures 59 and 60, respectively. The location of the ground line after failure indicates that only a small portion of the original embankment material was excavated prior to construction of the drainage blankets and berms. It is intended that the drainage blankets prevent subsurface seepage from the existing embankment into the newly constructed berm.

Figure 59. Remedial treatment of SLIDE-1, I-74, Indiana. Location shown in Figures 7 and 8 (courtesy of the Indiana State Highway Commission).

Slope flattening and berms generally require the acquisition of large amounts of additional borrow material and right-of-way. For example, the stabilizing berm shown in Figure 60 is extended to a distance of 260 ft beyond the toe of the original slope. Slope flattening and berms may not be feasible on sidehill fills unless the natural ground is relatively flat near the toe of the unstable embankment slope. In some cases, berms could be extended from the embankment slope to an opposing hillside. In these instances or any situation where natural drainage ditches or small streams paralleling the embankment are blocked, drainage structures will be required (for example, see Figure 59).
